# **ENVIRONMENTAL SURVEY AND ASSESSMENT OF GATEWAY ARMY AMMUNITION PLANT**

**FINAL REPORT**  
**June 1982**

4. TITLE (and Subtitle) Environmental Survey and Assessment of Gateway Army Ammunition Plant		5. TYPE OF REPORT & PERIOD COVERED Final Report December 1981 - June 1982

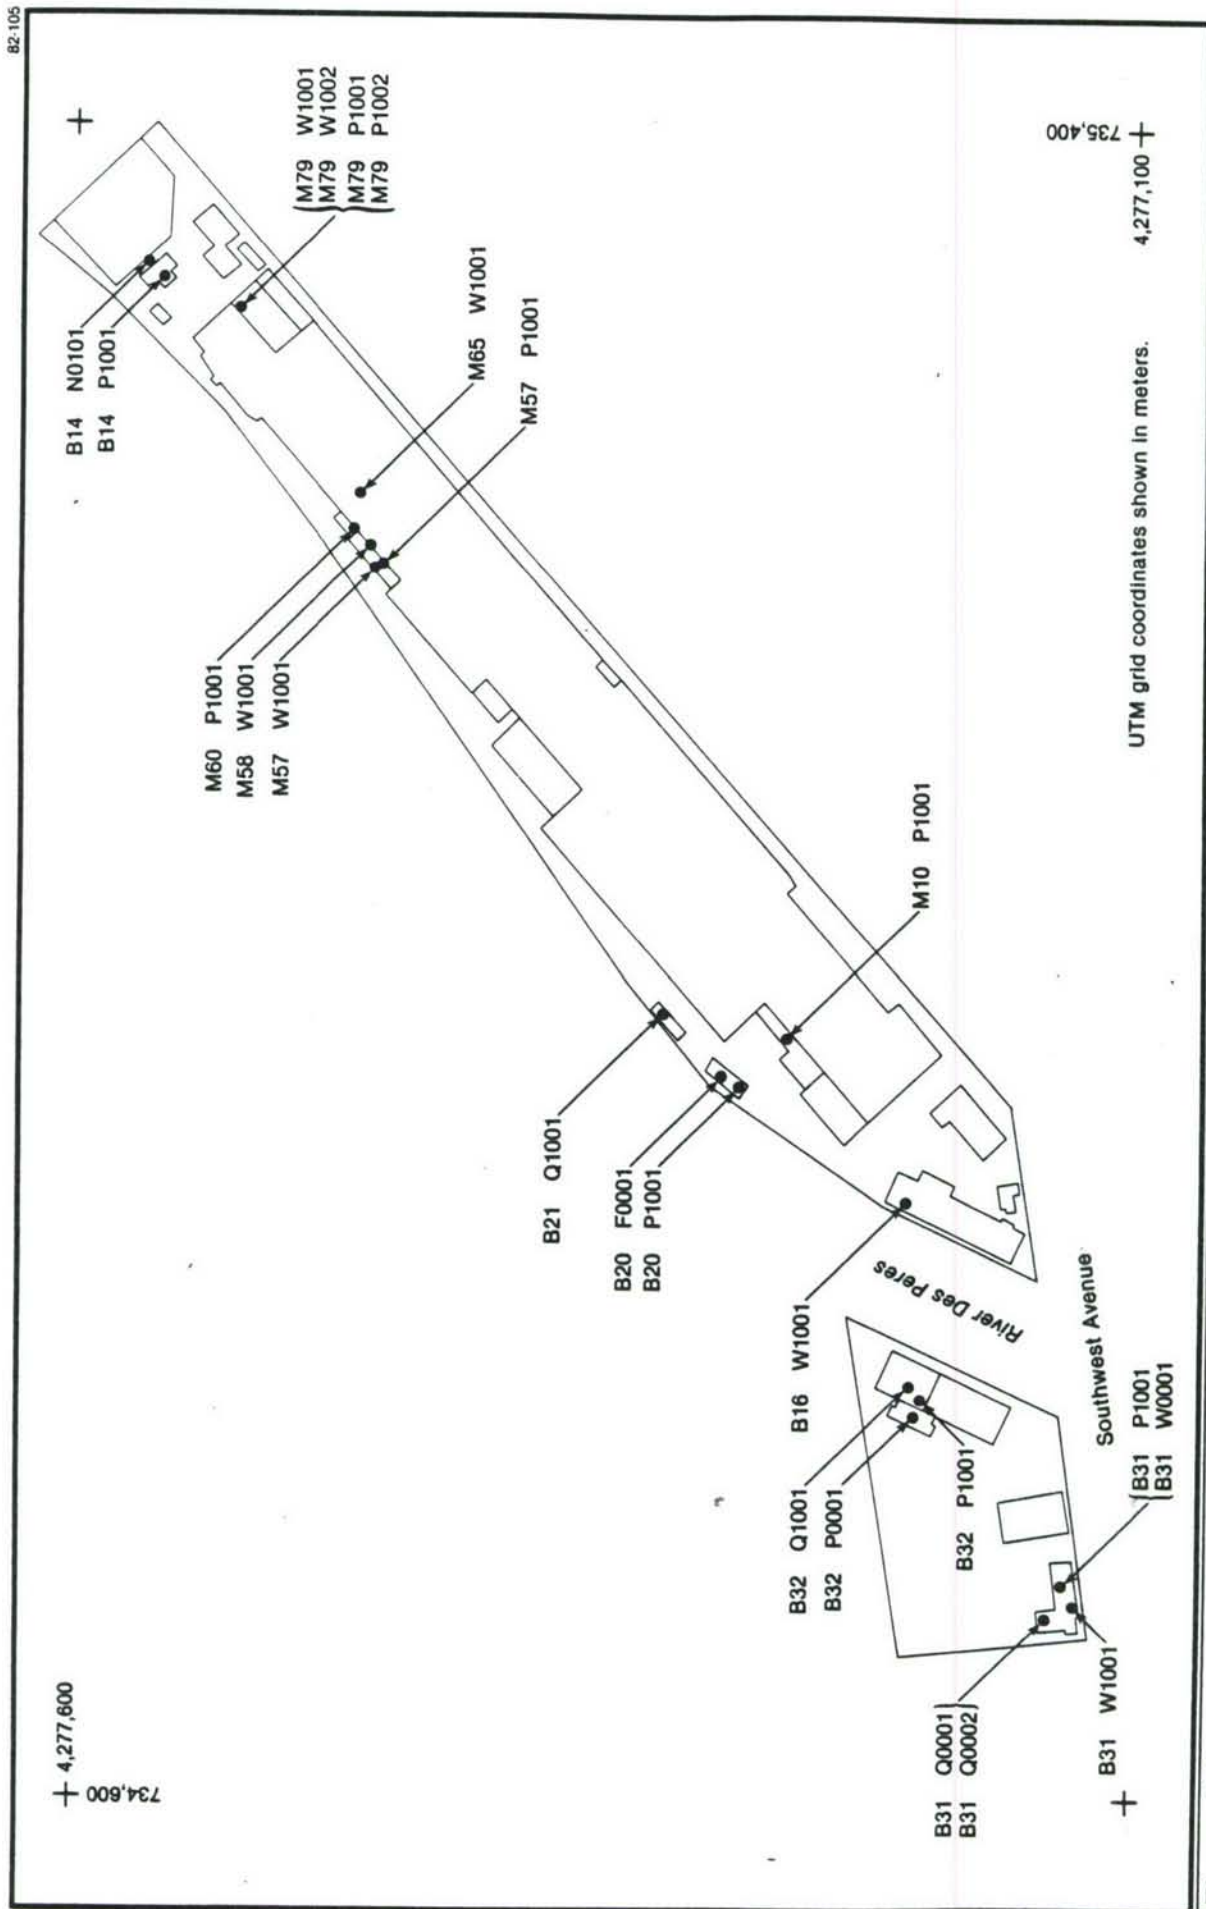
**Figure 3-1**  
**SAMPLING LOCATIONS FOR LEAD IN PAINT AND ASBESTOS IN INSULATION**

Many of the buildings contain significant areas of peeling paint. Exceptions are Buildings 21, 25, 18, and 47. In the occupied buildings (Buildings 16, 31, and 62), the areas which are in use are relatively free of peeling paint and in good repair. Unused portions of these buildings contain numerous areas of peeling paint. Section 4.0 presents a detailed inventory of the location of peeling paint in each building. The amount of peeling paint was estimated to constitute less than one percent of the painted areas of the installation overall.

The paint samples contained 0.09 to 2.75 percent lead; therefore, it is probable that all or nearly all peeling paint at GAAP exceeds the Consumer Product Safety Commission criterion for unrestricted use. No such criterion exists for paint used in industrial applications. Areas of GAAP where paint is not peeling are suitable for industrial use with no action with respect to existing painted surfaces. Areas where peeling paint occurs could present an exposure hazard in terms of airborne lead which is regulated to a maximum concentration in air of 0.15 milligrams per cubic meter ( $\text{mg}/\text{m}^3$ ) as a time-weighted average (TWA) in the working environment, according to the American Conference of Governmental Industrial Hygienists (USATHAMA, 1981b). If not removed, lead dust exceeding this limit could be generated during removal of peeling paint, renovation, or during future industrial activity. Undisturbed, the peeling paint does not release significant lead; no detectable lead was observed during the air monitoring phase at GAAP (see Section 3.6). Areas where paint containing lead is peeling are suitable for industrial use as long as an airborne lead hazard is

not present. All peeling paint containing lead posing an ingestion hazard must be removed prior to release for unrestricted use. However, paint that is not peeling is suitable for either industrial or unrestricted use.

In order to release GAAP for use restricted to industrial operations or activities, all peeling paint which must be removed, should be removed in accordance with sound Occupational Health and Safety Agency (OHSA) practices and disposed into a hazardous waste landfill. Such removal practice includes monitoring the airborne lead content and worker protection measures of wearing respirators, coveralls, and caps. OSHA regulations applicable to permissible airborne lead concentrations and worker protection are contained in 29 CFR 1910.1025. Paragraph (c) of the regulation specifies permissible lead levels; worker protection requirements are described in paragraphs (f) (respiratory protection) and (g) (protective work clothes and procedures).

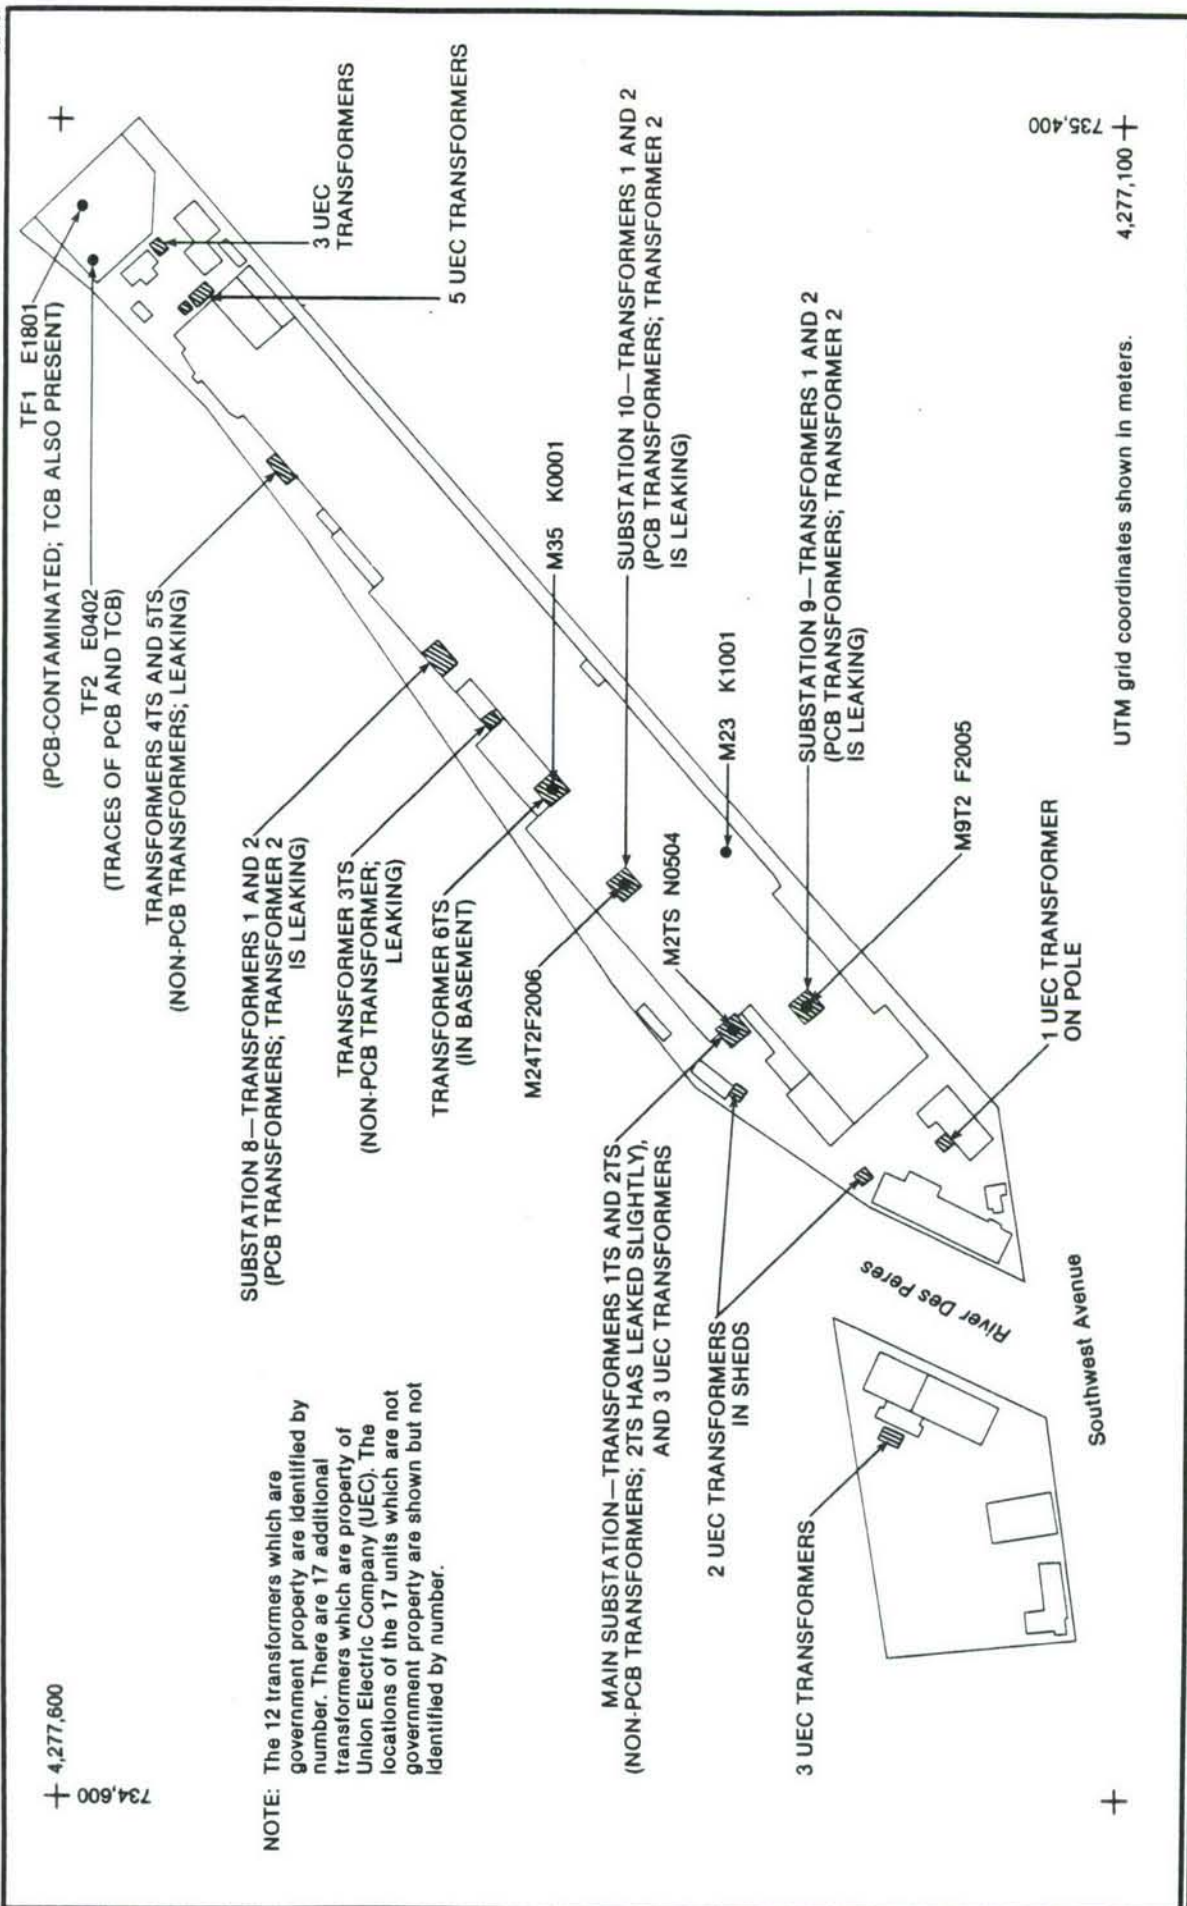
**Figure 3-2**  
**LOCATION OF ELECTRICAL TRANSFORMERS AND PCB AND TCB**  
**SAMPLING LOCATIONS**

An inventory and inspection of all transformer locations at GAAP was made as a part of the survey in order to determine whether any of the in-service equipment was leaking. At present, there is no out-of-service electrical equipment at GAAP. A total of 12 transformers at the installation are U.S. Government property. At present 17 transformers, all located outside of the GAAP buildings, are the property of Union Electric Company (UEC). The locations and designations of this equipment are shown in Figure 3-2.

The results of analysis and inventory therefore show that in-service (but de-energized) transformers at GAAP contain PCBs and TCB and that these compounds are leaking in the Main Manufacturing Building. The leaking transformers constitute improper use of PCB-containing equipment (EPA, 1979b) (44 Federal Register, 31514-31568) because the PCBs are not being used in a totally enclosed manner. Leakage also constitutes improper disposal of PCB. Results of the survey indicated that none of the UEC transformers are leaking, their PCB status is unknown; however, they do not need to be analyzed as long as they are in-service. Up-keep and removal are the responsibility of UEC. Leaking transformers which are the property of the U.S. Government must be repaired and the leaked material cleaned-up, containerized, labeled, and disposed of in accordance with regulations in Federal Register, 45(98):31530-31532 and 31543-31548 (EPA, 1980). In-service PCB transformers must be labeled in accordance with EPA regulations and inspected monthly for leakage.

Cleanup requirements for the U.S. Government transformers at GAAP, therefore, are to label and properly transport PCB and PCB-contaminated transformers in accordance with EPA regulations after repairing all leaking items. These items must be transported in accordance with Department of Transportation (DOT) requirements which call for packing the items in absorbant, inspection every three months, and labeling the container with EPA-approved PCB labels and as DOT classifications ORM-E.
